GFA AD-645
(ISSUE 1)

GFA AIRWORTHINESS DIRECTIVE

Subject: Main undercarriage legs inspection

Concerned: Motorglider G 109/ G 109B, all S/N's

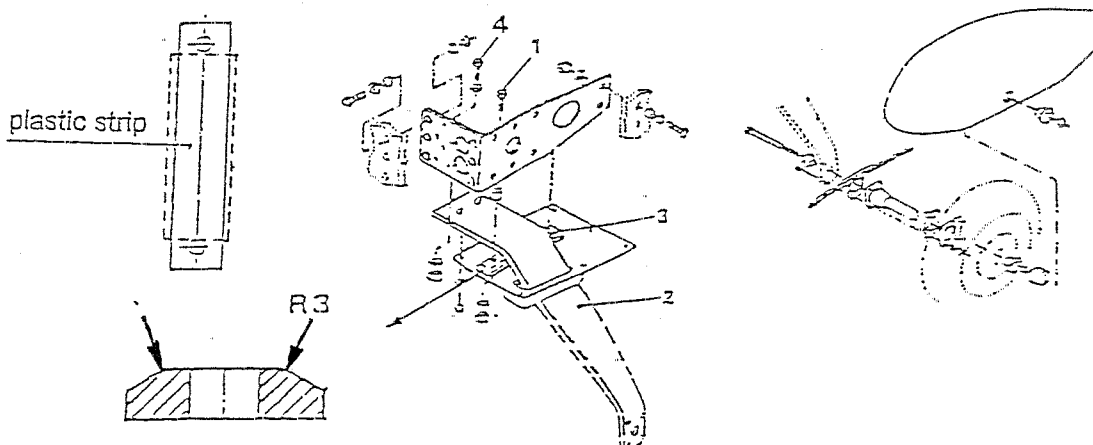
1. Support fuselage at the firewall and remove undercarriage fairings.
2. Remove 2 screws (1) and remove retaining bar (3).
3. Check retaining bar (3) for a radius (minimum R3) (refer to arrow).

4. If the radius exists, a plastic strip P/N 109-5000.07 must be glued to the bars (refer to sketch) to restrict the risk of fretting. The glueing area must be cleaned and degreased.
5. If the bar has sharp edges (i.e. no radius), a new bar (P/N 109-5000.02) with plastic strip must be installed.

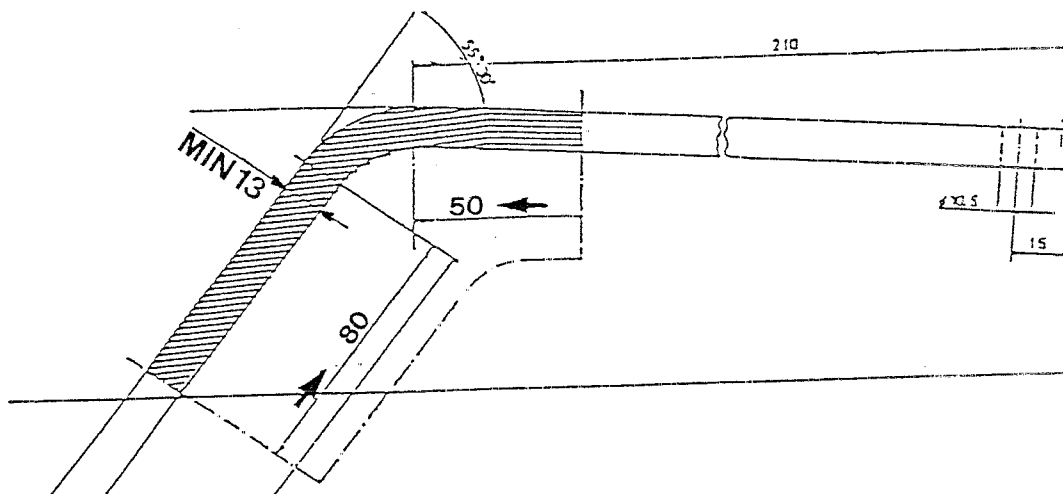
Caution: Pay attention only to remove the scaling coat. Do not cause additional scratches and grooves. Consider minimum thickness of 13 mm (refer also to workstep B.10.)!

8. Remove carefully and uniformly the scaling coat from the undercarriage leg (at the beginning use 60 grade emery paper, then use fine-grained paper up to grade 400).

10. If cracks are determined, the cracks can be polished to a depth of approx. 0,5 mm each side with a polish radius of approx. 100 mm and a peak-to-valley height of $\sqrt{2}$. The minimum thickness of 13 mm of the undercarriage leg must not be exceeded. If the minimum thickness is less than 13 mm at any position, the undercarriage leg has to be exchanged immediately.

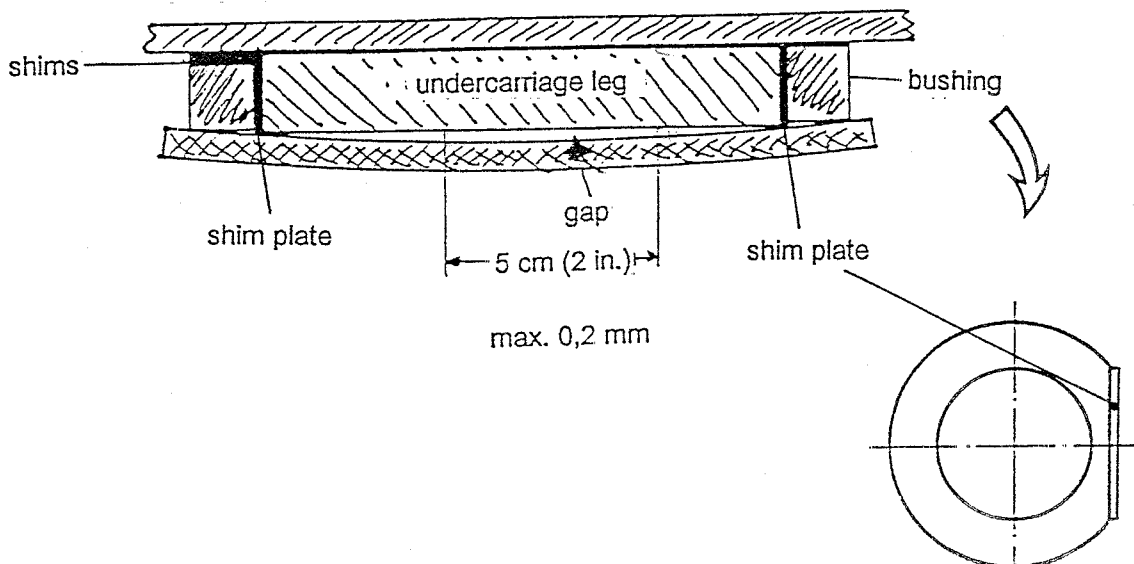
II. Pay attention, that no play is between undercarriage leg and bushing. Existing play must be removed as follows:

- glue shim plate P/N 109-5000.09, 1 mm thick, on to the bushing using Loctite 638 (curing time approx. 24 hours at room temperature and pressure, e.g. using a box clamp or a screw clamp)
- pay attention for a play free installation of the bushings, if necessary remove shim plate layers (each 0.05 mm) from front and rear bushing
