GFA AD-645
(ISSUE 1)

GFA AIRWORTHINESS DIRECTIVE

Subject: Main undercarriage legs inspection

Concerned: Motorglider G 109/ G 109B, all S/N's

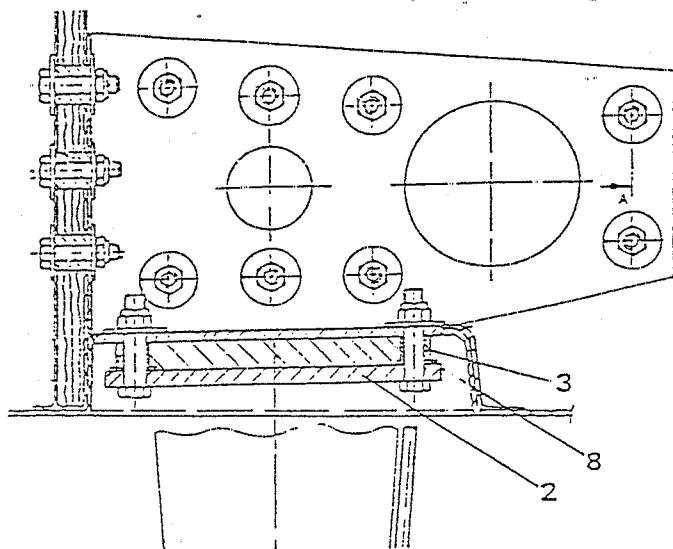
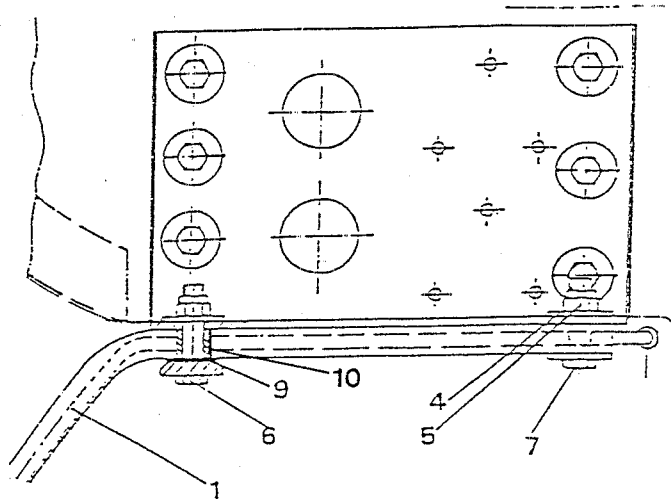
Direction of installation of screws (6) and (7):

- G 109 all S/N's and G 109B, S/N 6200 - 6445: from bottom to top
- G 109B, S/N as of 6500: from top to bottom
